DEPARTMENT OF TRANSPORTATION**DIVISION OF ENGINEERING SERVICES**

Quality Assurance and Source Inspection

Contract #: 04-0120F4Cty: SF/ALA Rte: 80 PM: 13.2/13.9File #: 69.15**SOURCE INSPECTION REPORT****Resident Engineer:**Siegenthaler, Peter**Address:** 333 Burma Road**City:** Oakland, CA 94607**Report No:** SIR-002895**Date Inspected:** 22-Jan-2011**Project Name:** SAS Superstructure**OSM Arrival Time:** 1500**Prime Contractor:** American Bridge/Fluor Enterprises, a JV**OSM Departure Time:** 300**Contractor:** Zhenhua Port Machinery Company, Ltd (ZPMC), Changxing Island **Location:** Shanghai, China**Quality Control Contact:** Mr. Don Walton**Quality Control Present:** Yes No**Material transfer:** Yes No N/A**Sampled Items:** Yes No N/A**Stock Transfer:** Yes No N/A**OK to Cut:** Yes No N/A**Rebar Test Witness:** Yes No N/A**Delayed/Cancelled:** Yes No N/A**Other:** Coating Inspection**Bridge No:** 34-0006**Component:** See Below**Bid Item:** 77, 78, 79**Lot No:** B #204**Summary of Items Observed:**

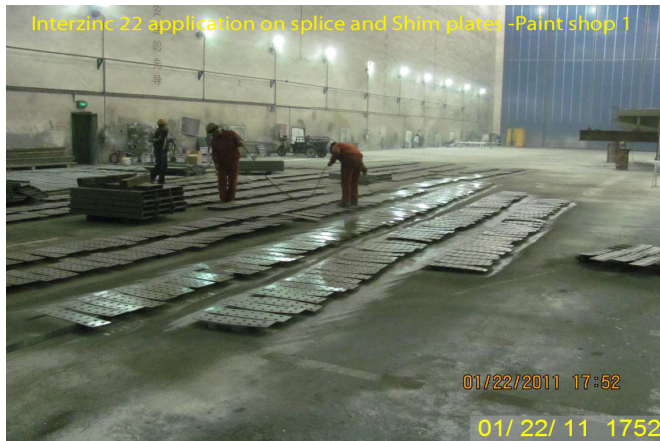
An inspection was requested on the OBG Splice plates -193 pieces and Shim Plates- 791 nos, vide inspection request no. 5823 for Surface preparation inspection before primer coat at Blasting shop 1. This QA inspector observed, ABF Inspectors Mr. Shi Stone found inspecting these surfaces. The profile measured by ZPMC QC Inspectors at 3 places found to be in the range of 80 to 86 microns. The salt test result carried out in 1 place found to be 16.1 US/CM. Both Profile and Salt test results found to be acceptable as per contract documents. Ambient conditions found measured by ZPMC QC Inspectors which is 8.4 deg. celcius above dew point and the relative humidity found to be 43.6 %, which is acceptable as per contract documents. International protective coatings technical service representative Mr. Li Peng was found present during the course of this inspection process for Technical discussion.

An inspection was requested on the Ladder -2nos, vide inspection request no. 5822 for Surface preparation inspection Before Galvanizing at Galvanizing workshop. This QA inspector observed, ABF Inspectors Mr. Wei found inspecting these surfaces. This was found accepted by ABF Inspector after minor touch ups and Grinding. International protective coatings technical service representative Mr. Li Peng was found present during the course of this inspection process for Technical discussion.
